PRECISION HOME INSPECTION, INC.

CONFIDENTIAL INSPECTION REPORT

City/State: Willow Spring, NC

Date of Inspection: 7/2/10

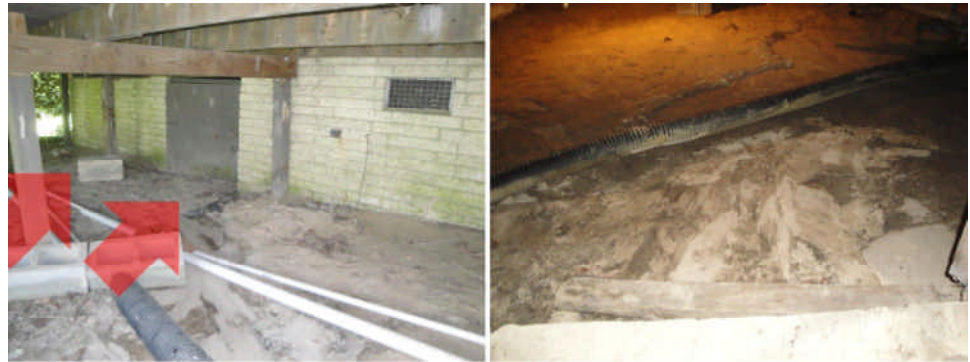
Grade at foundation needs correction at back side of house as wash trail was noted under screened-in porch leading to crawlspace. Grade should be made to slope away from house at least 6' and shed water away from house.

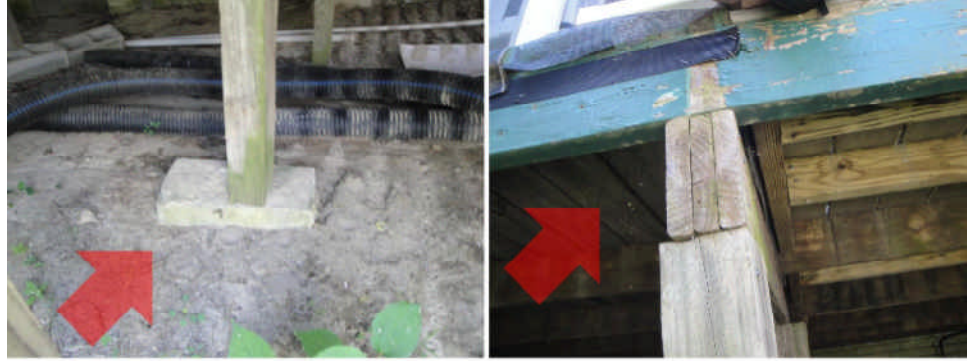
Deck was not professionally built as posts were not placed on permanent footers and band is undersized. Beam supporting roof structure appears to be screwed to house fascia trim. Should be further evaluated and repaired as needed by a licensed general contractor.

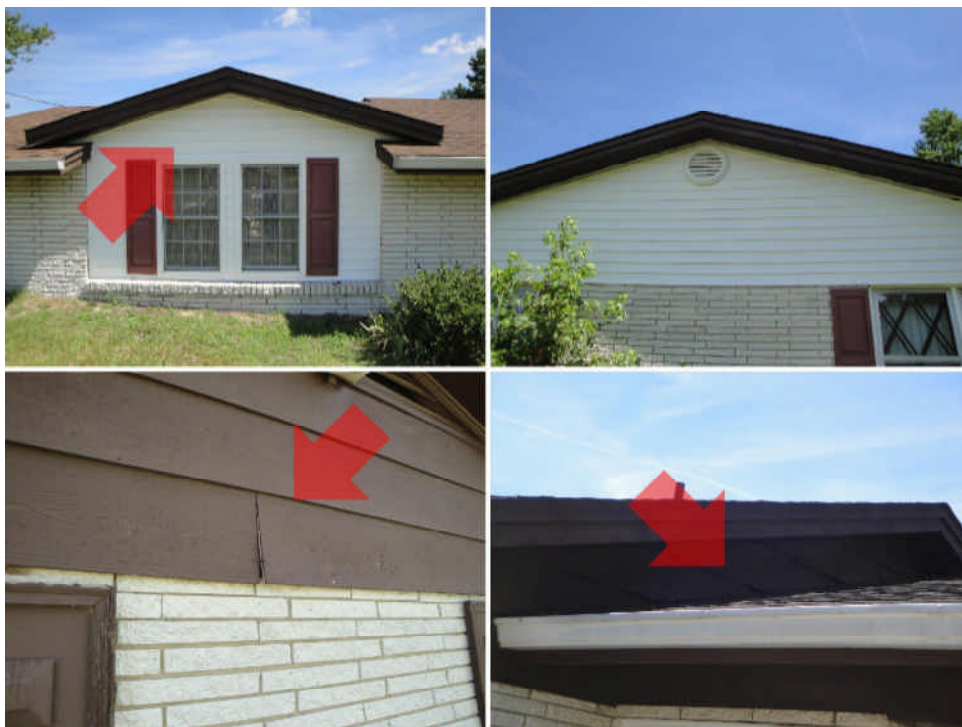
Moisture damage noted in siding on back left side of house at lower roof abutment to upper wall. All soft siding should be replaced.

Moisture damage noted in siding on left side of house above bricks. All soft siding should be replaced.

Vinyl siding was not properly installed on front side of garage and house. Should be further evaluated and repaired as needed by a professional vinyl siding installation company.

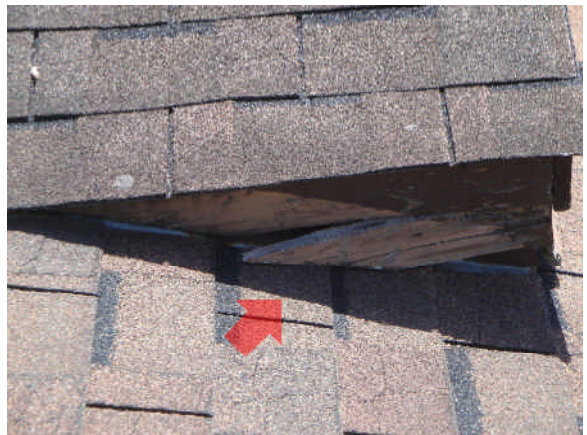
Material: Wood.
Condition: Noted moisture damage in trim on left side of front left gable. All soft wood should be replaced.

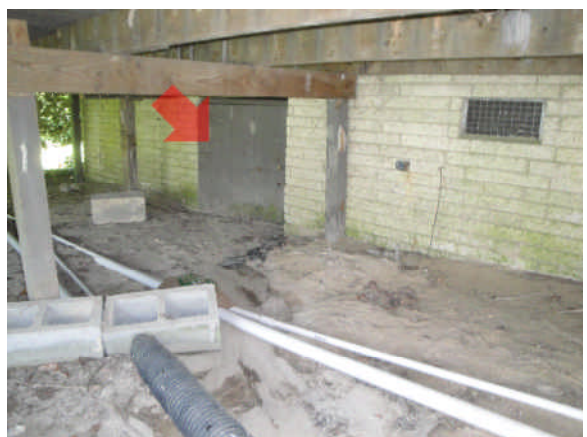
Condition: Functional.
Door frame/Trim: Crawlspace door and framing are deteriorated and need repair. Should be further evaluated and repaired as needed by a licensed general.

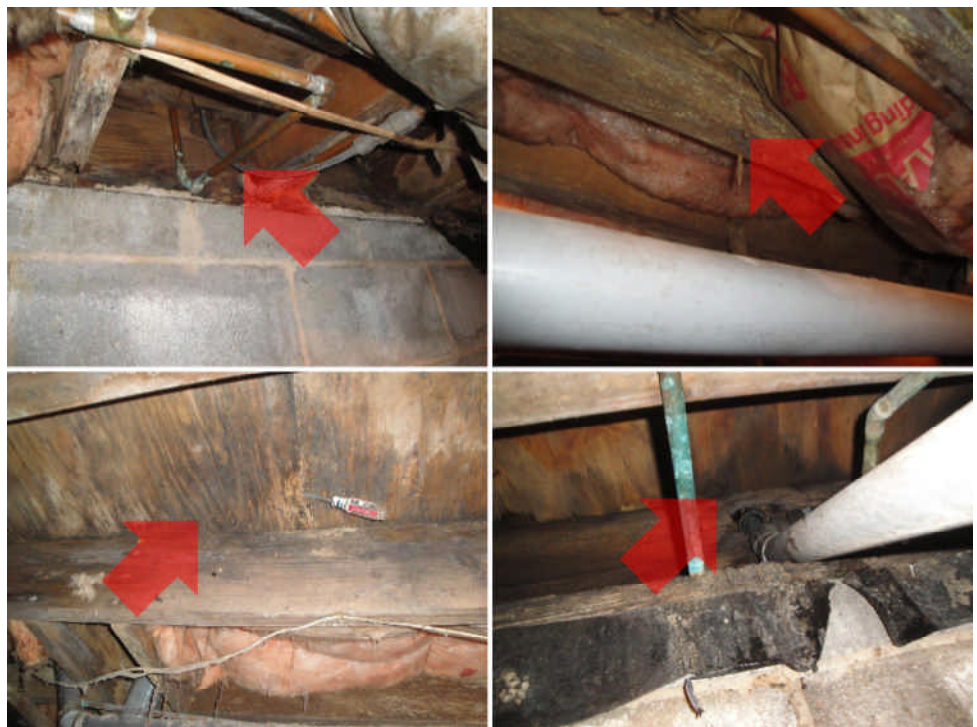
Noted significant damage to floor structure in multiple areas in crawlspace above the back, left, and front foundation walls, as well as, throughout the crawlspace. Crawlspace should be further evaluated thoroughly and repaired as needed by a licensed general contractor.

Noted substance that appears like mold on floor structure in multiple areas of crawlspace. Should be further evaluated and repaired as needed by a sanitation engineer.

Noted evidence of pests and damage in floor structure near front foundation wall. (See picture below). Should be further evaluated and repaired as needed by a licensed general contractor.

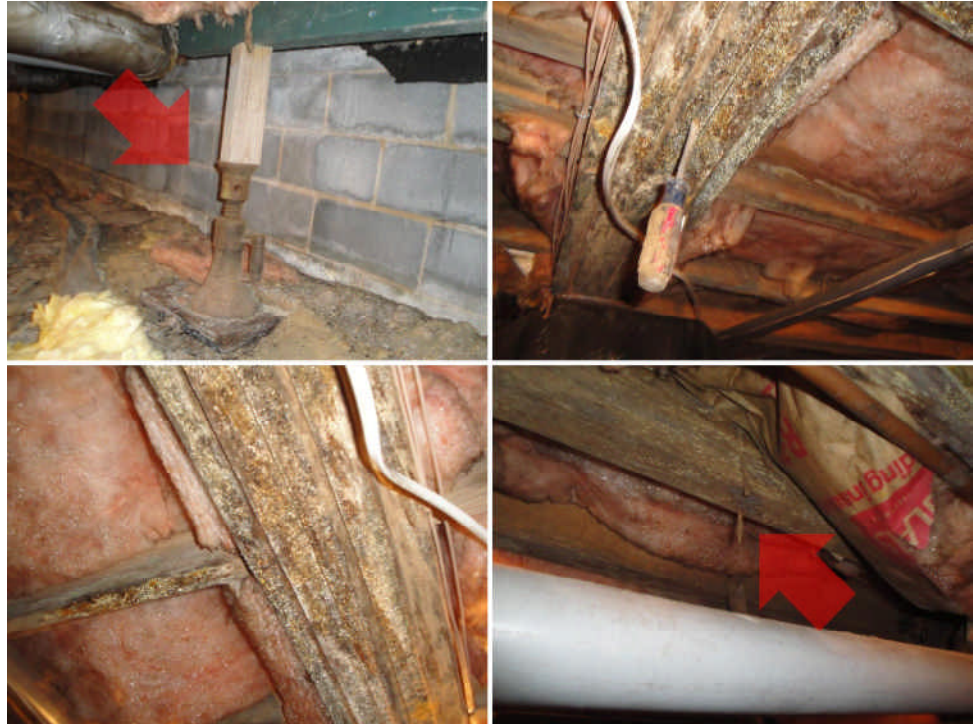
Noted significant moisture damage in girder in crawlspace. Should be further evaluated and repaired as needed by a licensed general contractor. Noted drop girder installed in front section of crawlspace that is not properly built and was placed on a wooden platform.

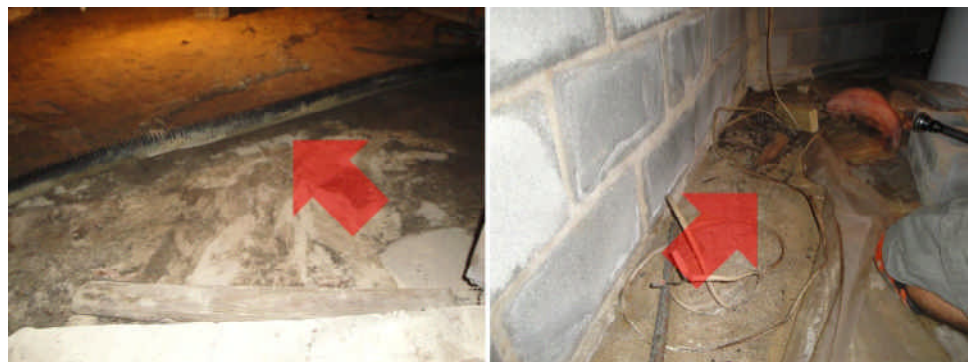
Evidence of previous water penetration was noted along the back, front, and left foundation walls. Source of water should be determined and corrected.

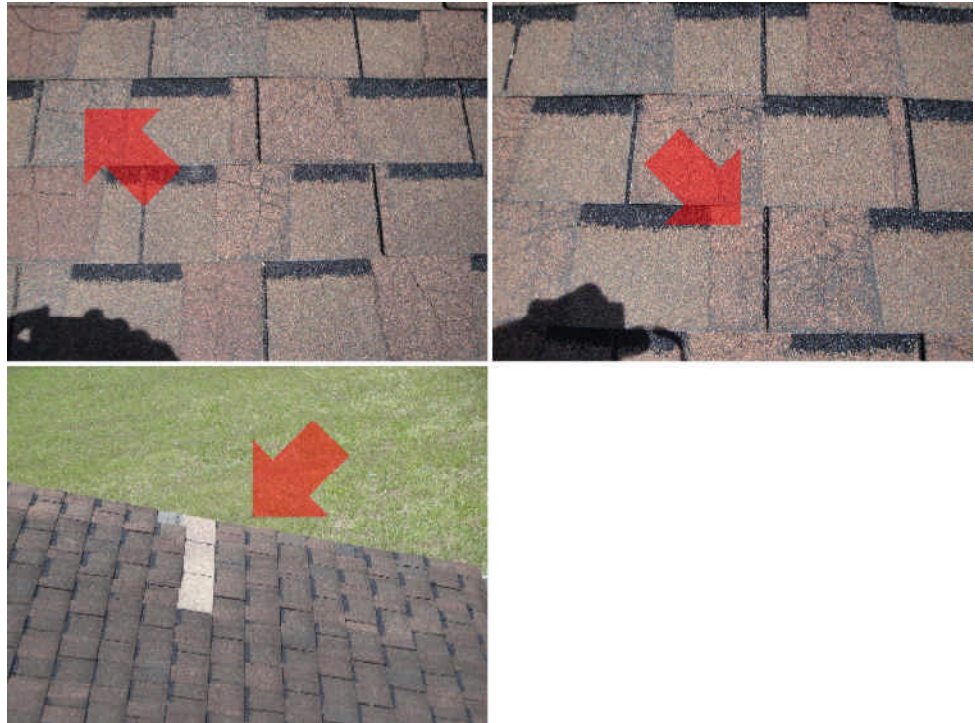
Noted significant cracking and damage in most shingles throughout roof. This is most likely due to the insufficient ventilation. Should be further evaluated and repaired as needed by a professional roofing contractor.

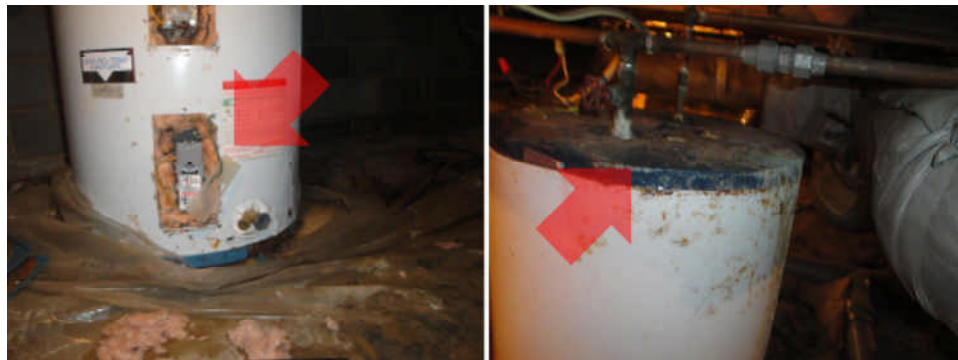
Pressure relief valve drain line is missing. This is a SAFETY HAZARD. We recommend this drain line be extended to within 6" of the floor or a safe location by a plumber.

Noted evidence of leak and corrosion in both water heaters in crawlspace. Water heaters should be further evaluated thoroughly and repaired as needed by a licensed plumber.

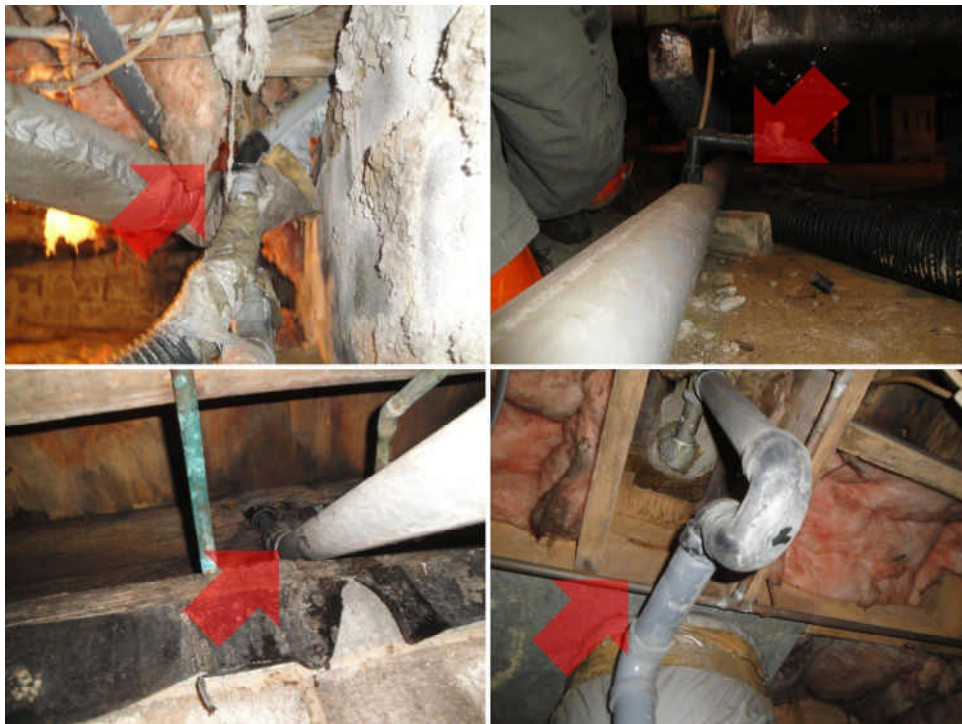
Noted disconnected 2" drainline in back left section of crawlspace that has been dumping into crawlspace for an extended period of time. Should be further evaluated repaired as needed by a licensed plumber.

Noted unusual gray drainline piping in crawlspace. Should be further evaluated and repaired as needed by a licensed plumber.

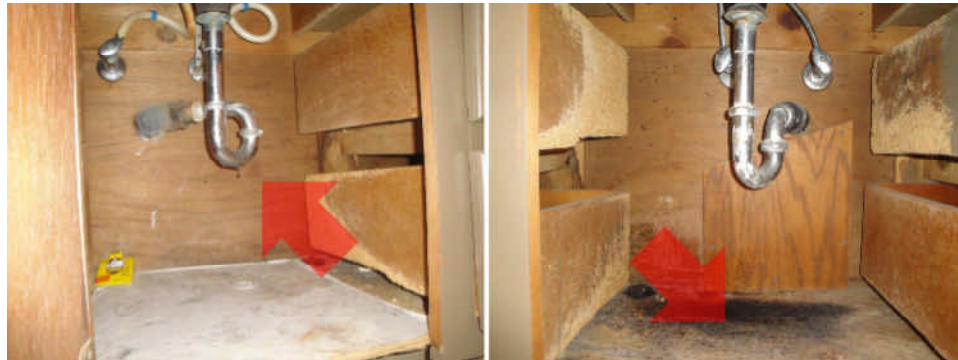
Slow drainage noted in laundry room sink. Should be further evaluated and repaired as needed by a licensed plumber.
Sink stopper does not function properly in back middle bedroom bathroom sink. Should be repaired as needed by a licensed plumber.
Leak noted under buddy bathroom sinks. Should be further evaluated and repaired as needed by a licensed plumber.
Bathroom sink is not properly secured to wall structure. Should be further evaluated and repaired as needed by a licensed plumber.

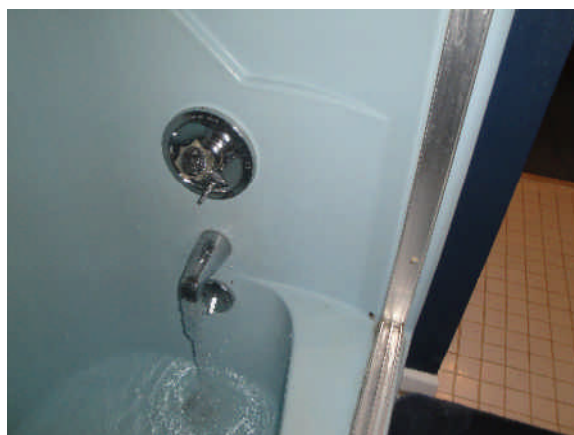
Noted holes/chips in master bathtub unit. Should be further evaluated and repaired as needed by a licensed plumber.

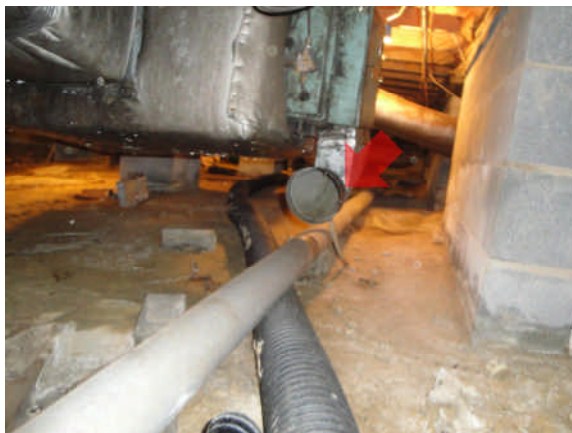
Ducts/Air Supply: Ductwork is disconnected in crawlspace. Should be further evaluated and repaired as needed by a licensed HVAC contractor.

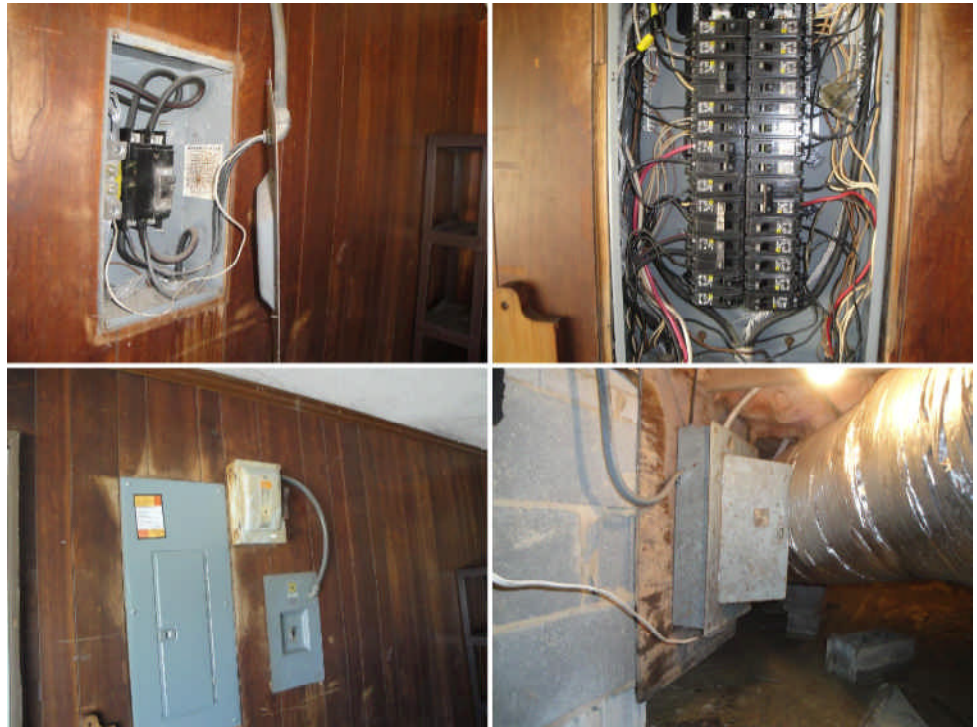
Multiple wires are connected to a single lug on a circuit breaker(s) where only one wire should be connected. Should be further evaluated and repaired as needed by a licensed electrician.

Over fusing or (over sized breaker) in electrical panel (fuse or breaker size too large for wire size). This could allow more electricity to pass through the wire than it can safely handle and cause it to overheat. Should be further evaluated and repaired as needed by a licensed electrician.

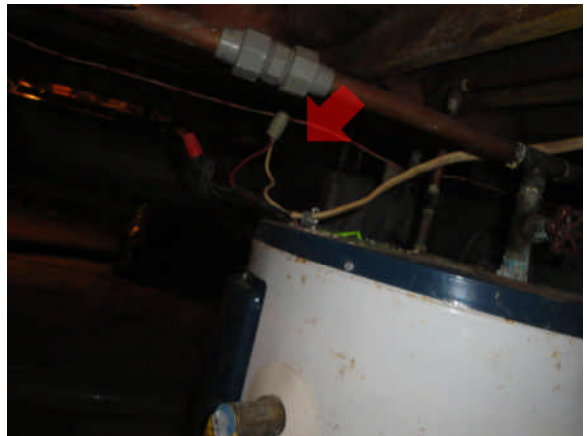
Service disconnect by gas pack heater is rusted and door has fallen off. Should be further evaluated and repaired as needed by a licensed electrician.
Noted loose unprofessional wiring above water heater in crawlspace. Should be further evaluated and repaired as needed by a licensed electrician.

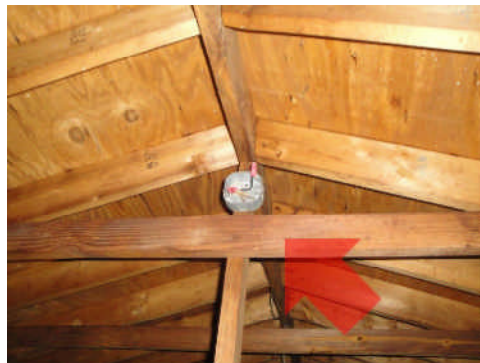
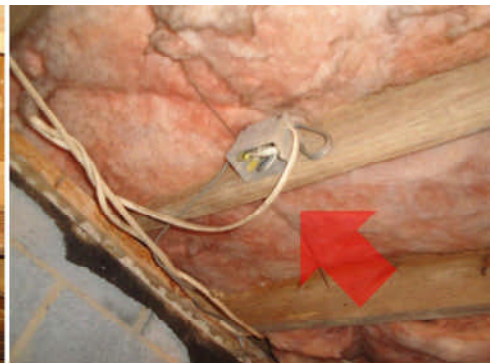
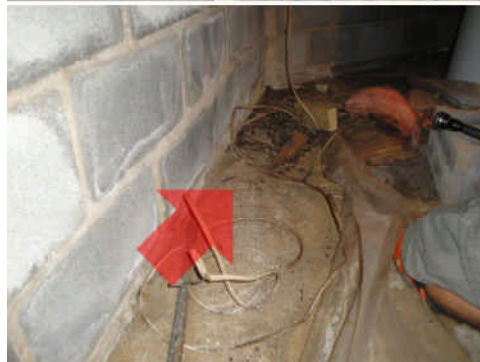
Copper. A representative sampling of switches and outlets was tested. As a whole, outlets and switches throughout the house are in serviceable condition. Stored items prevent access and testing at some outlets and switches. Noted broken cover on front exterior outlet. GFCI protection is either not present or not operational in exterior receptacles. Should be further evaluated and repaired as needed by a licensed electrician. Unprofessional modifications or repairs have been made to the electrical system. It is recommended that a licensed electrician inspect entire electrical system. Open splices in wiring is visible in the both the attic and crawlspace; this is considered unsafe. All wire terminations or splices should be contained in junction boxes with cover-plates. Should be further evaluated and repaired as needed by a licensed electrician.

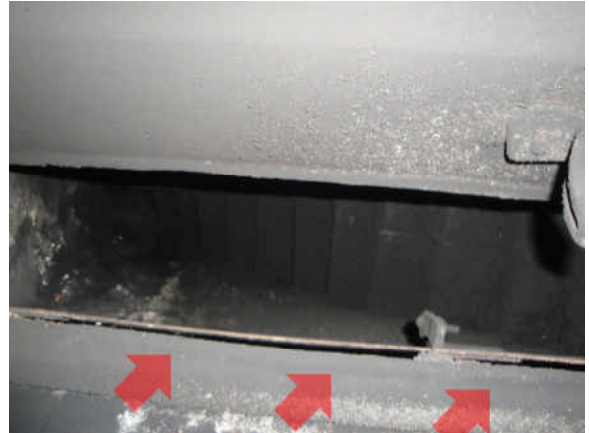
Noted gaps in masonry in smoke chamber, off centered flue tiles and a broken damper handle. Should be further evaluated and repaired as needed by a certified chimney sweep.

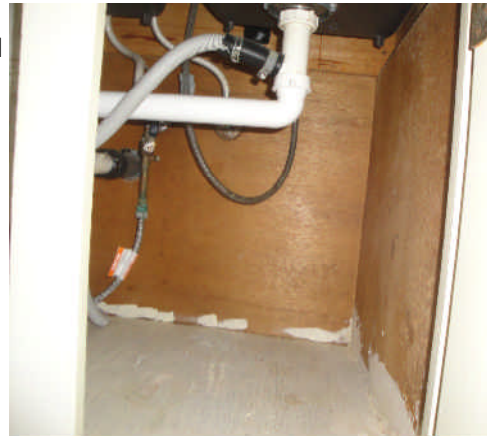
Type: Porcelain.
Condition: Leak noted under kitchen sink. Should be further evaluated and repaired as needed by a licensed plumber.

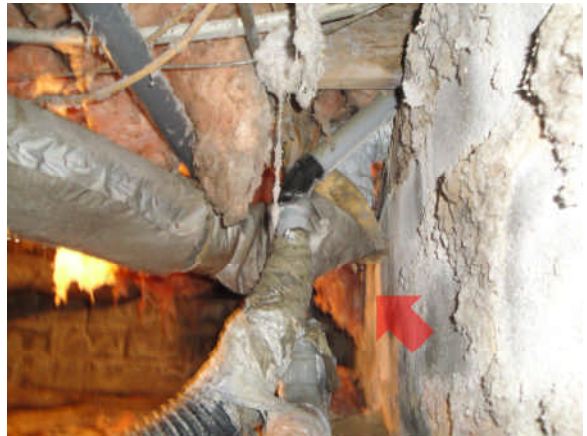
Condition: Electrical outlet is grounded. Dryer vent duct is disconnected in crawl space. Dryer vent duct should be replaced with a metal duct and extended to the exterior.
