PRECISION HOME INSPECTION, INC.

CONFIDENTIAL INSPECTION REPORT

City/State: Willow Spring, NC

Date of Inspection: 7/2/10

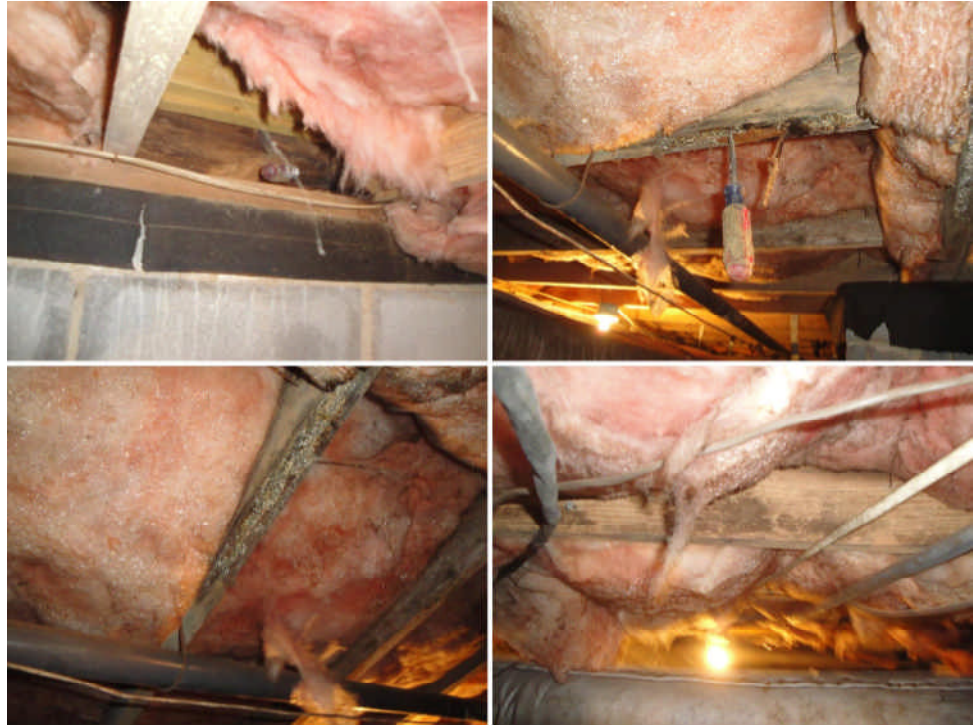
There are no readily visible problems noted in foundation. Pictures above and below show concerns in first floor structure.
